Can Appropriate Thermal Post-Treatment Make Defect Content in as-Built Electron Beam Additively Manufactured Alloy 718 Irrelevant?

Goel, S., Bourreau, K., Olsson, J. et al (2020). Can Appropriate Thermal Post-Treatment Make Defect Content in as-Built Electron Beam Additively Manufactured Alloy 718 Irrelevant?. *Materials*, 13(3). <http://dx.doi.org/10.3390/ma13030536>

Article

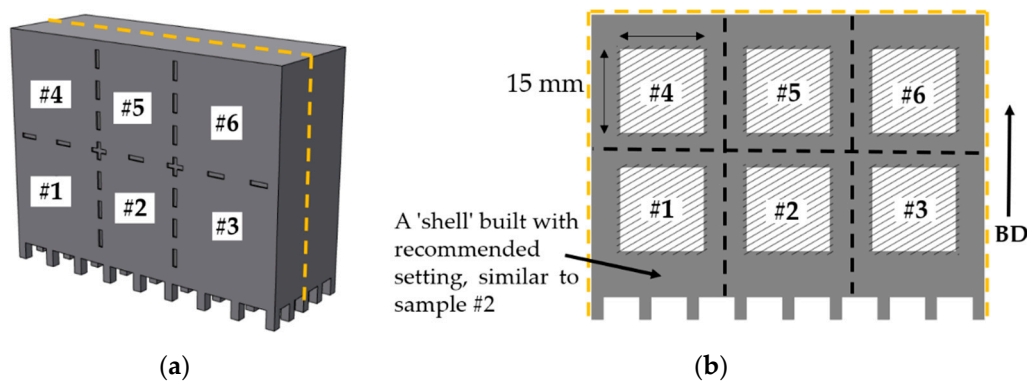
Figure 1. Schematic of the CAD model of one of multiple identical blocks comprising the electron beam melting (EBM) build (a), and cross-section view of the block revealing the cubes (marked by hatched lines) processed with different line spacing (b). The arrow on the right shows the build direction, BD.

Samples were EBM built with different defect contents by varying LS to assess their response to identical post-treatments, particularly HIPing. Plasma atomized Alloy 718 powder (AP&C, Québec, Canada) [5] recycled ~20 times was used. Six different samples (15 × 15 × 15 mm³) (Figure 1), henceforth referred to as AB#1 to AB#6, were built using EBM (Model A2X, Arcam AB, Gothenburg, Sweden) with varying LS corresponding to different processing speeds (expressed as relative melting time and relative melted area per unit time by normalizing with the “standard” values), as summarized in Table 1. All the samples were melted by a snake hatch method during which the electron beam was moved in a back-and-forth raster scan pattern [18]. All the other process parameters were kept constant as per the EBM process theme version 4.2.205, and some of the key process parameters associated with this theme are listed in Table 2. It is worth mentioning that the parameter speed function dynamically adjusts the electron beam scan speed depending on the scan length [22].

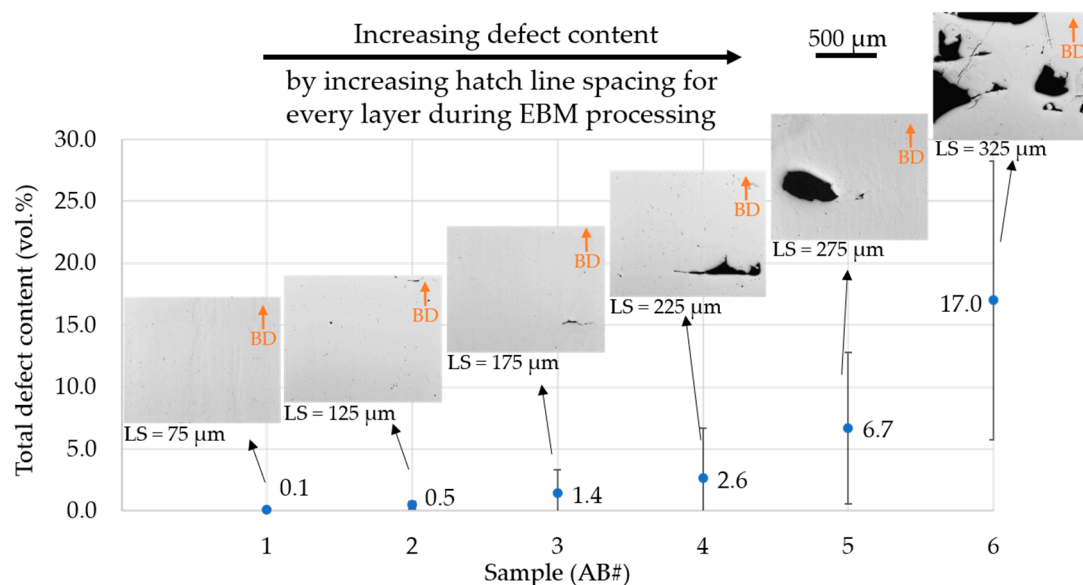
Figure 2. Defect content in as-built samples intentionally built with varied hatch line spacing (LS). The size and amount of defects are visualized in the insets. Arrows in the inset indicate build direction.

The as-built microstructures of samples processed with varying LS corresponding to different melting speeds (Table 1) are depicted in Figure 2. Increase in LS above the “recommended” value resulted in a rise in the defect content, as shown in Figure 2. The defect contents stated represent the sum of all types of defects observed in the as-built samples, i.e., gas and shrinkage porosity, and lack of fusion. Incidentally, these defects were also present in samples produced at the recommended LS = 125 μm (AB#2) as well as at lower LS = 75 μm (AB#1). Samples intentionally produced with higher LS exhibited defect contents up to 17%, as shown in Figure 2 and also visualized in accompanying micrographs. In a word, a systematic increase in line offset (processing speed) from 75 to 325 μm resulted in an increased defect content ranging from 0.1% to 17% in the investigated samples. It is worth mentioning that large defects such as those observed in samples AB#5 (LS = 275 μm) and AB#6 (LS = 325 μm) are not typical of an EBM built even with not fully optimized processing conditions [23]. However, these samples were produced for the present ‘proof of concept’ investigation regarding the extent of defect closure enabled through HIPing.

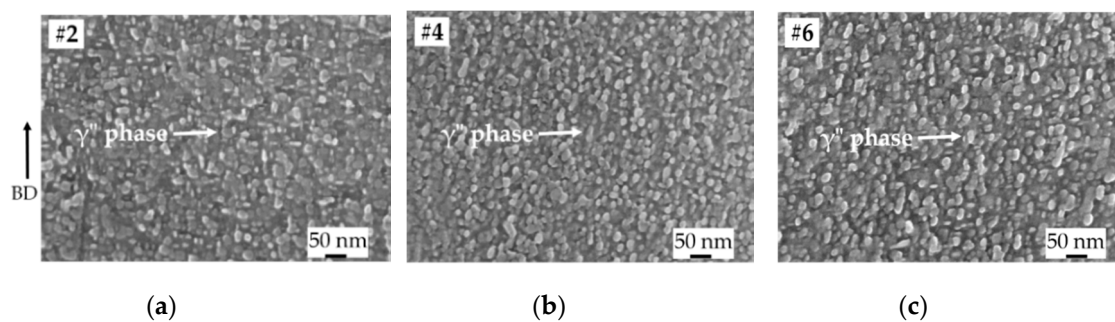
Figure 6. SEM micrographs of HIP1 + STA samples (a) LS = 125 μm , (b) LS = 225 μm , and (c) LS = 325 μm showing similar distribution of the γ'' phase. The arrow indicates the build direction.

observed in solution-treated EBM Alloy 718 that was not subjected to prior HIPing [10]. The effect of aging treatment can be readily seen from the similar distribution of γ'' phase as shown in Figure 6a–c. These microstructural similarities in the three samples (HIP1 + STA #2, #4, #6) were also reflected in the microhardness results, as described below.

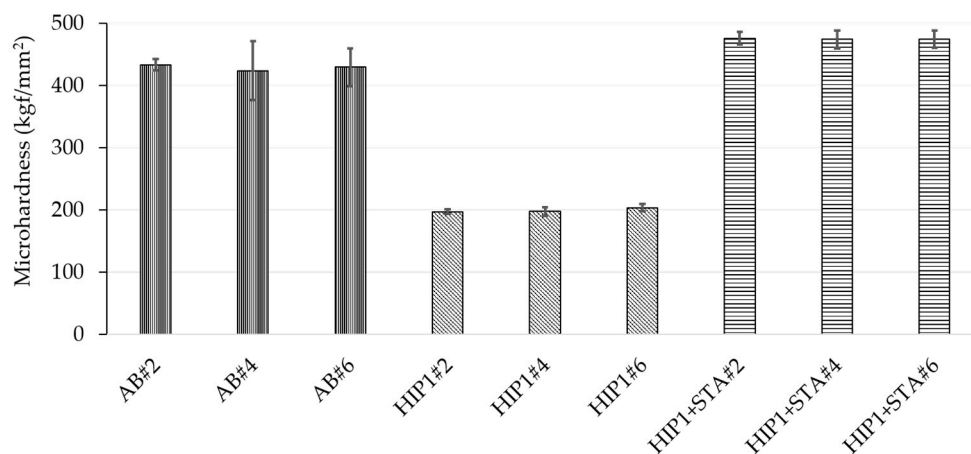
Figure 7. Microhardness values of the as-built and post-treated samples #2 (LS = 125 μm), #4 (LS = 225 μm), #6 (LS = 325 μm).

The average microhardness values of the as-built and post-treated samples, determined as previously described in the experimental procedure, are shown in Figure 7. It can be seen that, although the defect contents in the as-built samples were vastly different, they exhibit similar hardness values of $\sim 430 \text{ kgf/mm}^2$. This can be explained by the similarity in local melting conditions for the three as-built specimens, as the electron beam parameters were unchanged, and only the line spacing was varied. This contrasts a previous reported study by Lee et al. [23], where hardness was observed to vary ($405\text{--}450 \text{ kgf/mm}^2$) with defect content ($4.5\%\text{--}0.5\%$) of the EBM Alloy 718 samples. In the study by Lee et al. the local melting conditions were varied between the different specimens by changing the focus offset, thereby influencing energy density. The HIP1 treatment caused a reduction in the hardness of all the samples to nearly identical values of $\sim 200 \text{ kgf/mm}^2$. This is consistent with the previous observations on EBM and LPBF Alloy 718 [30,31]. After HIP1 + STA, all the samples exhibited similar hardness values ($\sim 475 \text{ kgf/mm}^2$), which were higher than in the as-built condition. This value is close to the reported peak hardness ($\sim 490 \text{ kgf/mm}^2$) of Alloy 718 [10]. Previous studies on EBM Alloy 718 have also reported an increase in hardness in the as-built condition from 410 kgf/mm^2 to 470 kgf/mm^2 after aging [32–34]. Thus, the foregoing results amply reveal that, regardless of the vastly different defect content in the as-built condition, the final post-treated condition exhibits a very similar density (Figure 3), phase constitution in terms of δ phase and γ'' phase distribution (Figures 5 and 6), as well as microhardness values (Figure 7).
